Freescale Semiconductor Errata (or Chip Errata)

Document Number: MC33661ER
 Rev. 3.0, 01/2014

MC33661, Masks M98Z and L06R, Errata

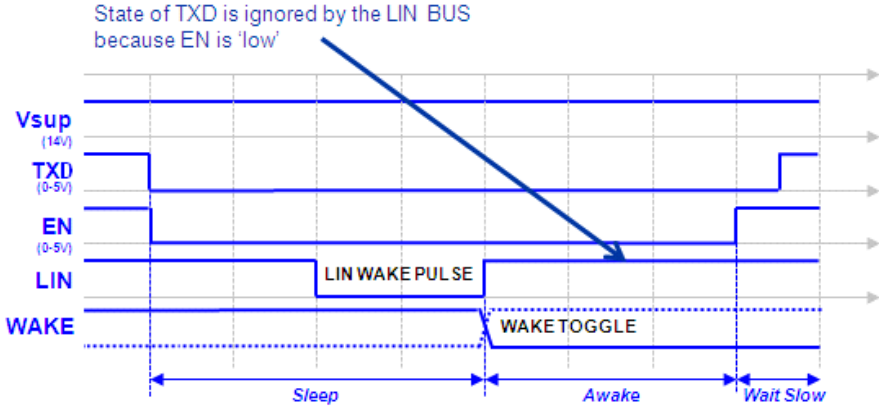
<p style="text-align: center;">Figure 1. Expected Behavior</p>
ER02

Errata No.	Erratum	System Impact	Description
Low Severity			
ER02	LIN BUS driven by TXD when EN is 'low'	When the anomalous behavior is present, the LIN bus will be driven by the state of TXD even if EN is 'low'. When transitioning from Awake into Wait Slow state, the TXD must be 'low', so in this case, the LIN will be driven 'dominant'. In this state, communication on the LIN bus is not possible during the duration of TXD 'low'. Figure 1. and Figure 2.	<p>During the transition into Sleep state (pulling EN pin 'low') and then transitioning into the Awake state by receiving a LIN wake-up pulse or a WAKE pin toggle, the TXD could drive the state of the LIN, even if the EN pin is 'low'. If this occurs and the TXD pin is low, the LIN pin will be driven dominant until the TXD pin goes high. Empirical measurements show that the probability of this anomalous behavior is in the range of 1 out of every 4000 transitions into Sleep state (EN pin pulled 'low').</p> <p>Root Cause: The anomalous behavior is caused by an asynchronous event when EN is pulled 'low' at about the same time (within a few nanoseconds) as an internal oscillator signal goes 'high'. This creates a race condition of the state machine, and one of the two signals required for the LIN transmitter to be activated does not transition properly, remaining in the enable state. Once the transceiver receives a LIN wake-up pulse or the WAKE pin is toggled, the other necessary signal to activate the LIN transmitter is triggered and the state of TXD drives the LIN bus, even though it should be disabled.</p> <p>It should also be noted that when the issue occurs, the sleep current (I_{SLEEP}) increases from 8.0 typ. to 71 μA at 13.5 V. When the state machine transitions properly, this extra current draw is not present.</p> <p>Workaround:</p> <ol style="list-style-type: none"> 1. Ensure the TXD pin is in the "high" state during Sleep and Awake modes. In this case, even if the driver is enabled, a dominant pulse is not present on the bus when the anomalous behavior occurs. The consequence to this method is that it is not possible to transition the device to the Wait Slow mode, and ultimately Slow mode operation, because TXD needs to be low during Awake mode to transition to the Wait Slow state. 2. When the anomalous behavior is present, the node issuing a wake-up signal on the LIN bus must retry by sending a new wake up signal (in accordance with section 2.6.2 WAKE-UP of the LIN 2.2 specification). This method allows the continued use of Slow mode. <p>Fix Plan/Status: None</p>
