# **5 VOLT FlashFile™ MEMORY**

## **28F004S5, 28F008S5, 28F016S5 (x8)**

### **SPECIFICATION UPDATE**

Order Number: 297796-007

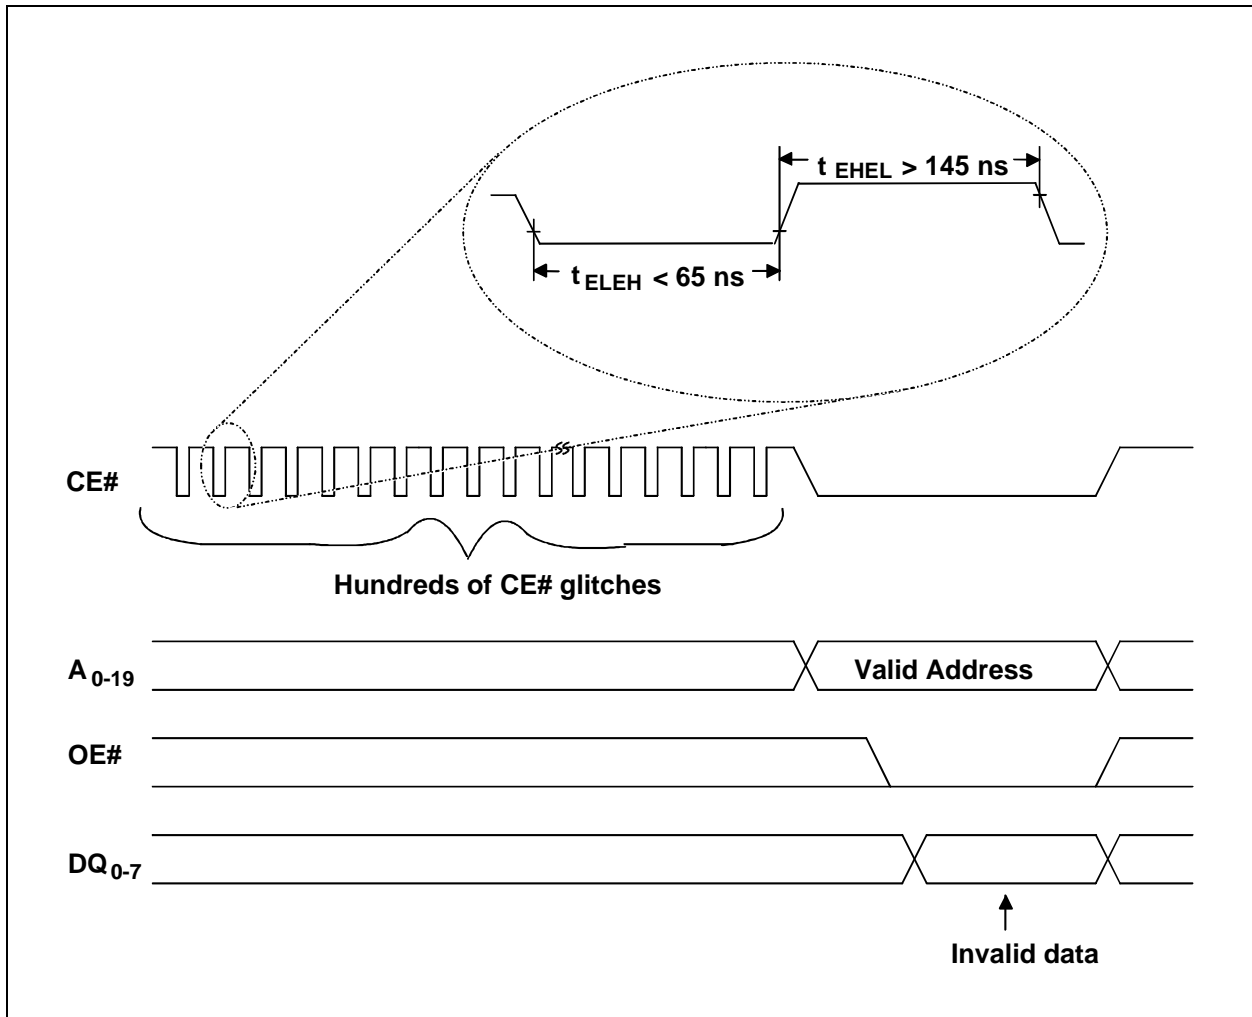
**PROBLEM:** A noisy CE# control signal may cause an invalid read. This erroneous read only occurs after the device has received over one hundred consecutive short CE# glitches ( $t_{EHL} < 65 \text{ ns}$ ) with CE#-high time ( $t_{EHEL}$ ) greater than 145 ns (see the figure below, *A Long Series of CE# Glitches May Induce an Invalid Read*).

**A Long Series of CE# Glitches May Induce an Invalid Read**

After valid data is read, the device must receive another series of CE# glitches (typically over one hundred) to induce an invalid read.

**IMPLICATION:** This erratum may affect read operations in systems that have a lot of noise on the flash memory's CE# input. If CE# is generated asynchronously from the upper address lines, noise on CE# can sometimes occur when upper address lines transition from one state to another. However, applications that access flash memory sequentially will have stable upper address lines and will therefore produce fewer CE# glitches. Systems that execute code from flash memory or download code from flash memory into DRAM will usually access the device sequentially; therefore, they will be less susceptible to this erratum.

Add system logic to prevent CE# glitches such as latched CE# control logic or pullup/pulldown resistors to the address bus.

If the device receives over one hundred consecutive CE# glitches, issue a Byte Write command and program FFh to any location before executing a read operation. Programming FFh will not alter stored data, but it will give the component sufficient time to prepare for the read operation.

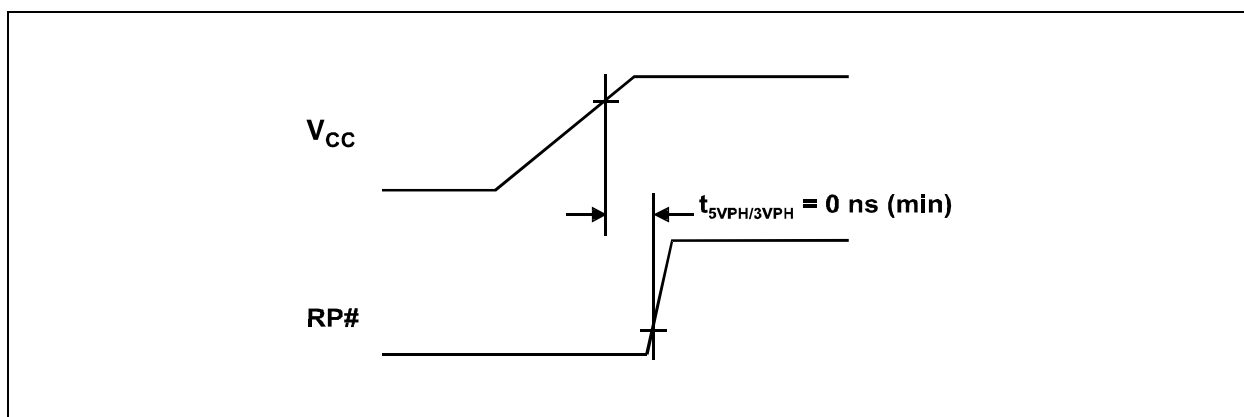
**PROBLEM:** RP# must be held low while V<sub>CC</sub> ramps to a valid level during power transitions.

**Hold RP# Active While V<sub>CC</sub> Ramps**

Holding RP# low during power-up blocks spurious writes initiated by system control logic which may occur as the system voltage transitions to a stable level. Intel recommends the use of RP# for CPU/memory reset synchronization, write protection, and deep power-down mode.

**IMPLICATION:** This erratum only affects power-up operations. Systems that tie the flash memory's RP# input to the system RESET# signal typically will not have a problem with erratum because the RESET# signal is usually held low during the power-up sequence to properly synchronize the CPU. However, systems that tie RP# directly to V<sub>CC</sub> will be more exposed to this problem. So, carefully analyze RP# during the power-up condition to fully understand its behavior.

Use a simple RC delay network to hold RP# low during the power-up condition or tie the RP# input to the system RESET# signal. This workaround will eliminate your exposure to this problem and also provide your design with addition power-up security.
