# Intel<sup>®</sup> 80219 General Purpose PCI Processor

## Specification Update

Document Number: **274020-002**

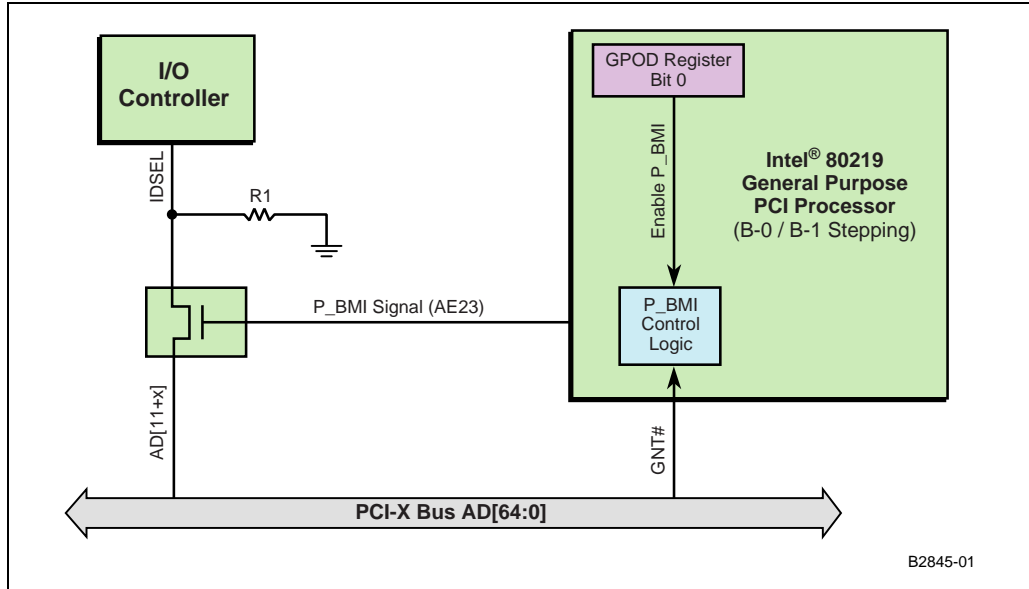
**Figure 2. Intel® 80219 General Purpose PCI Processor P\_BMI Signal Implementation for Intel® 80219 General Purpose PCI Processor B-0/B-1 Stepping**

The IDSEL signal is used as a chip select during configuration cycles initiated by the BIOS, operating system or 80219. The GPOD[0] can be driven low in firmware, thereby disabling the P\_BMI signal and hiding the host I/O device from the system, by turning off its IDSEL. When the 80219 intends to perform configuration cycles in the PCI bus segment of the I/O device, the P\_BMI signal should be asserted high by driving the GPOD[0] high. The affect of these two operations is, that the I/O device is initialized and controlled by the 80219. More care must be taken with the gate chosen to control IDSEL, since most host bridge controllers do not use PCI address stepping. With IDSEL being a synchronous signal, with respect to CLK, the switch used must be a sub nanosecond propagation delay device (e.g., Pericom PI5C3303). In Figure 2, the P\_BMI signal is used to control a MUX/DeMUX switch that is used to enable/disable IDSEL to the I/O device.

**Note:** The host BIOS does not require any modifications to accommodate this implementation. All the responsibility for I/O device configuration and resource falls to the 80219 firmware.
