Panduit D10-250C-D

Disconnects for Use in High Vibration Applications (Case 1)

Disconnects for Use in High Vibration Applications

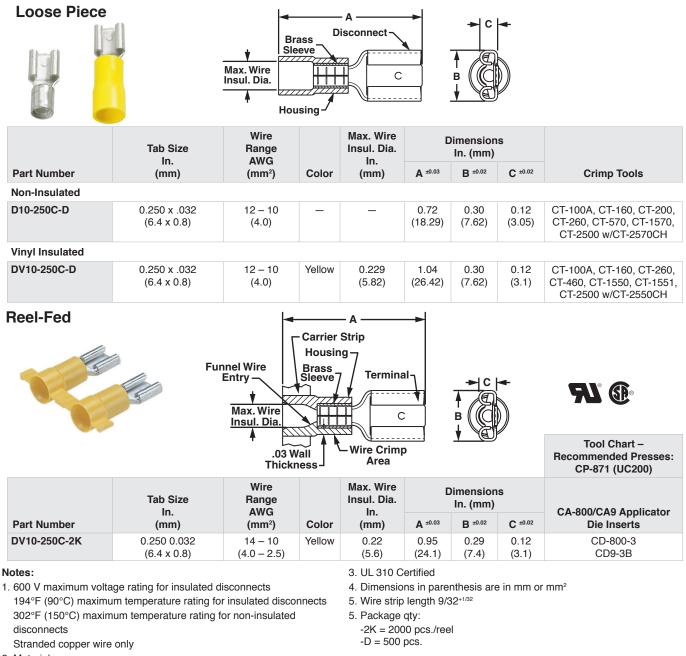
2. Material:

a. Stamping: CDA-260 brass, tin-plated

b. High withdrawal force curl design

c. Housing: Vinyl

Panduit developed vibration resistant female disconnect samples for testing in this application. The solution required a higher disconnect withdrawal force to overcome the failures caused by the high vibration. As seen circled in the images on the right, the samples that passed were designed without the curl slots to increase the retention force between the curls of the female disconnect and the male tab. This increased retention force directly increased the frictional force, which ultimately delivers a higher disconnect withdrawal force. The customer evaluation of the new design showed that none of the vibration resistant female disconnects slipped off the male tabs. Customer downtime as a result of disconnects vibrating off of the male tabs has been eliminated since implementation of this product.
